American Home Inspections of NE NC

Page 1 of 23
Unit #46010A

Property Address US Coast Guard Housing, Unit #46010A Kinnakeet Rd

Client Name U S Coast Guard

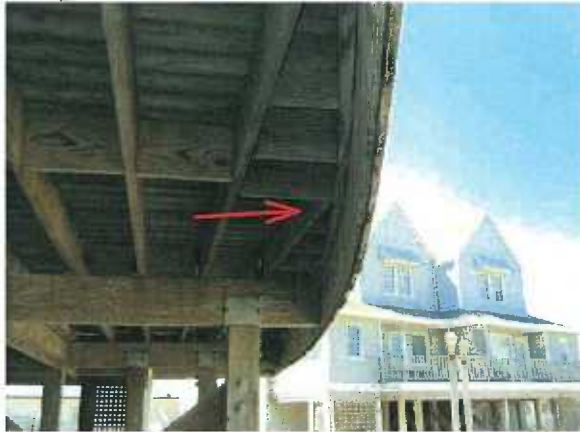
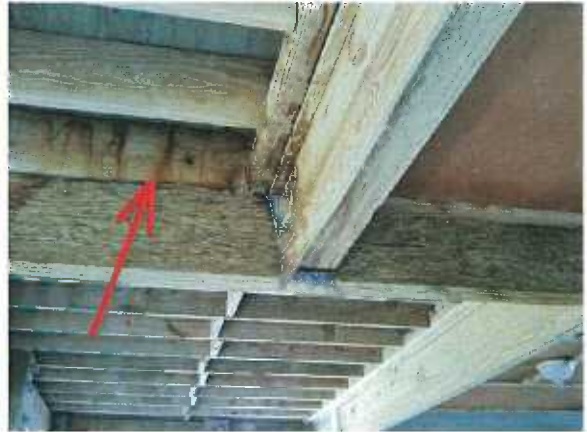
Deck: Front, Pressure Treated Wood The front deck handrails and wood pickets are deteriorated and should be replaced.

From under the deck, the floor joist below the party wall above, the floor joist are stained. This indicates that moisture is migrating from the roof through the party wall and exiting under the house in the carport.

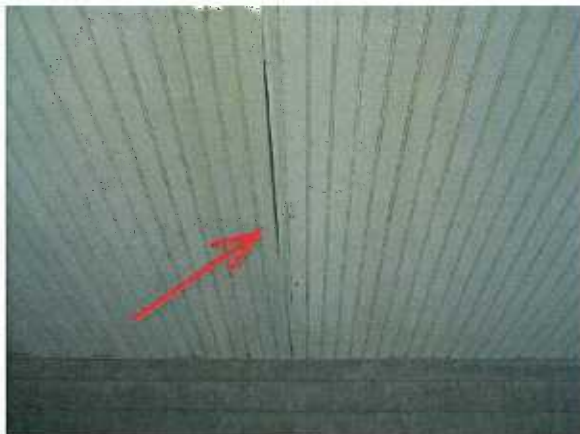
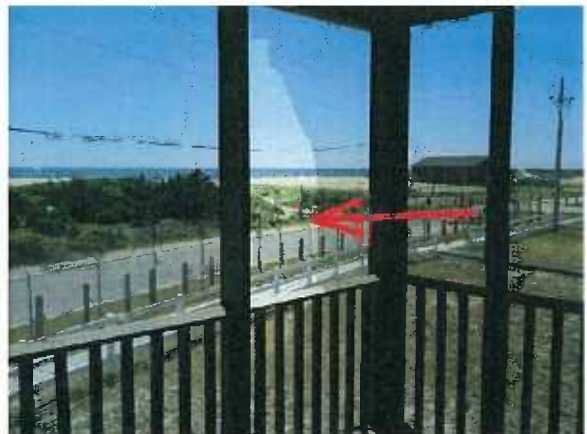
Porch: Rear Porch, Pressure Treated Wood Screen panels for the porch are missing or damaged. The porch screen door is damaged.

There is one place where the ceiling soffit panels are bulging downward.

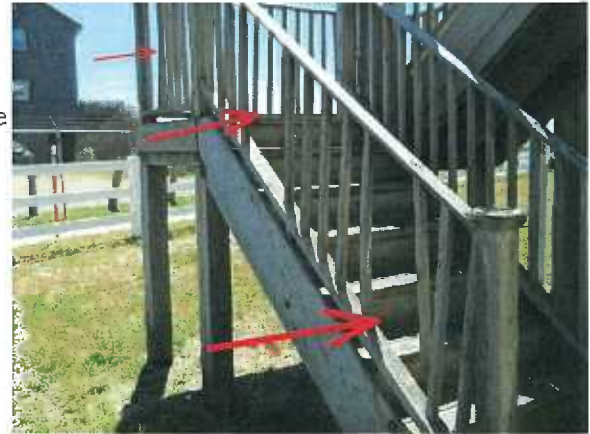
6. ☐ ☐ ☐ ☐ ☒ Stairs/Landings: Rear Stairs & Landing, Pressure Treated Wood The 2X2 wood pickets are loose and missing. The nails holding the pickets in place have rusted away.

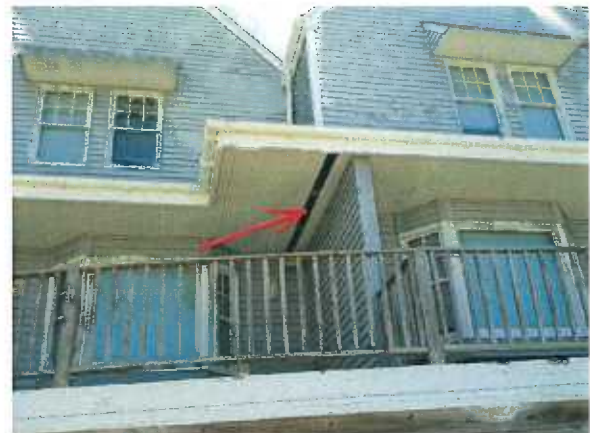
9. ☒ ☐ ☐ ☐ ☐ Trim: Wood, Aluminum Covered
 10. ☒ ☐ ☐ ☐ ☐ Fascia: Wood, wrapped with Aluminum Coil Stock
 11. ☐ ☐ ☐ ☐ ☒ Soffits: Vinyl panels There is one soffit panel missing from the soffit at the front of the house.

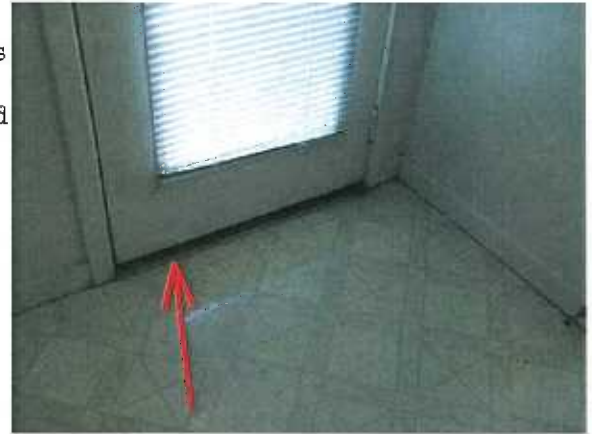
15. ☐ ☐ ☐ ☒ ☐ Entry Door: Kitchen/Dining Area, Fiberglass, Full View Glass Moisture is migrating to the inside at the door threshold. The door and threshold need to be adjusted to stop the moisture migration.

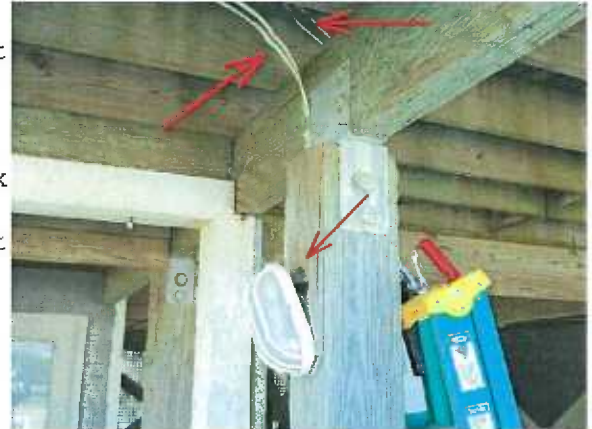
18. ☐ ☐ ☐ ☐ ☒ Exterior Lighting: Exterior, Surface Mount There is one light fixture at the front of the house that is not properly mounted to its intended surface. There is a exterior light under the front deck that was wired with interior romex wiring that should have been installed in electrical conduit. There is a light installed for the rear stairs. The interior romex wiring for this light should have been installed in electrical conduit.

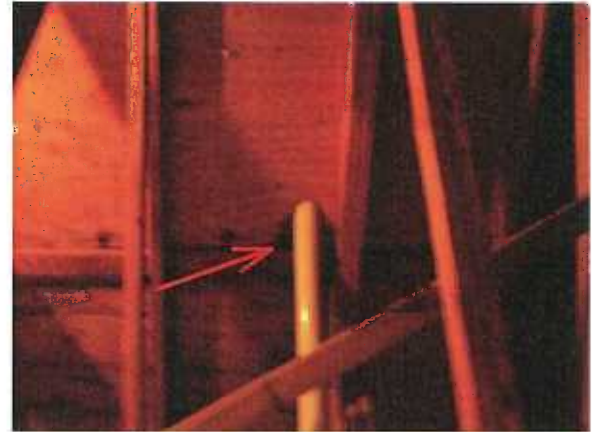
1. Method of Inspection: On roof
2. ☒ ☐ ☐ ☐ ☐ Material: Asphalt shingle
3. Type: Hip & Gable
4. Approximate Age: 14 to 16 years
5. ☒ ☐ ☐ ☐ ☐ Flashing: Metal
6. ☒ ☐ ☐ ☐ ☐ Valleys: Asphalt shingle
7. ☐ ☐ ☐ ☐ ☒ Plumbing Vents: PVC The 3 inch plumbing vent, there are moisture stains around this pipe in the attic that indicate the plumbing vent has failed.

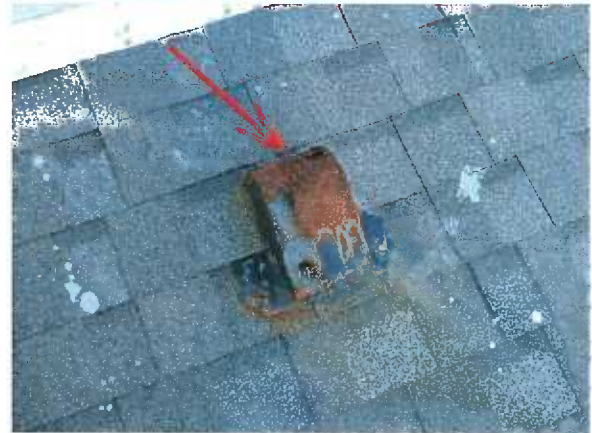
8. ☐ ☐ ☐ ☐ ☒ Ventilation Vent: Metal One of the metal ventilation vents is deteriorated to the point it is allowing moisture to enter the interior of the house.

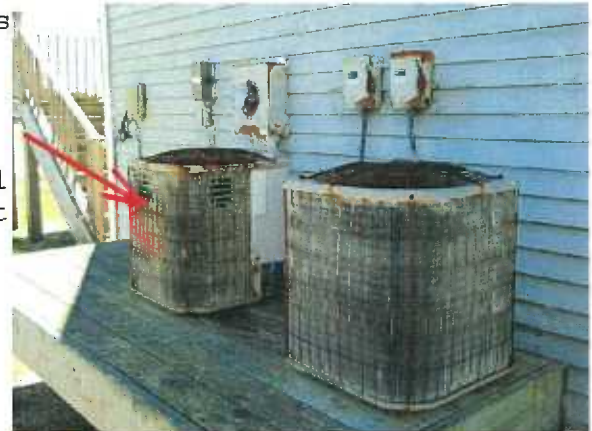
1. ☐ ☐ ☐ ☐ ☒ A/C System Operation: Inoperative
2. ☒ ☐ ☐ ☐ ☐ Condensate Removal: Plastic tubing
3. ☒ ☐ ☐ ☐ ☐ Exterior Unit: Mounted on wooden platform
4. Manufacturer: Carrier
5. Area Served: Ground & Mid Levels Approximate Age: 12 to 14 years
6. Fuel Type: Electric Temperature Differential: x
7. Type: Heat pump Capacity: 2 ton
8. ☐ ☐ ☐ ☐ ☒ Visible Coil: Copper core with aluminum fins
The aluminum fins surrounding the copper coil are becoming deteriorated and falling away from the copper coil. The aluminum fins are present to dissipate the heat from the copper coil and when the fins are no longer present the coil will over heat and the condenser will cease to function.

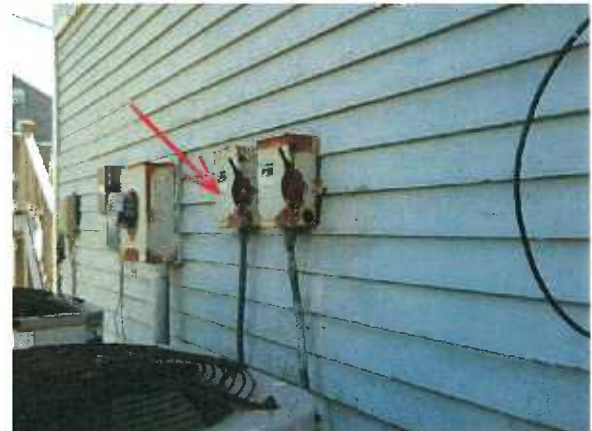
9. ☐ ☐ ☐ ☐ ☒ Refrigerant Lines: Rubbertex Insulation The black rubbertex insulation on the copper tubing is deteriorated and should be replaced.

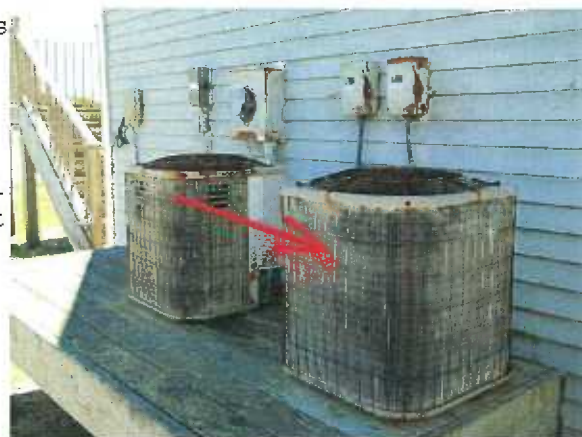
18. ☐ ☐ ☐ ☒ ☐ **Visible Coil:** Copper core with aluminum fins. The aluminum fins surrounding the copper coil are becoming deteriorated and falling away from the copper coil. The aluminum fins are present to dissipate the heat from the copper coil and when the fins are no longer present the coil will over heat and the condenser will cease to function.

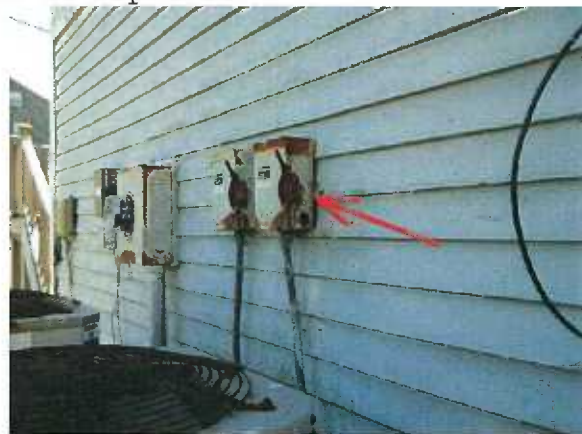
20. ☐ ☐ ☐ ☒ ☐ **Electrical Disconnect:** Tumble switch. The HVAC electric disconnect box is very rusty.

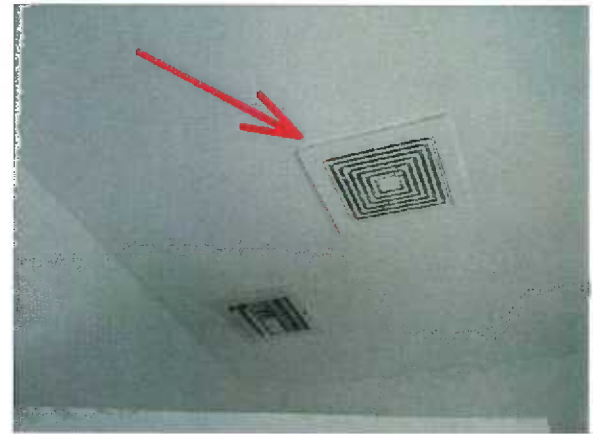
1. ☐ ☐ ☐ ☐ ☒ Ceiling: Drywall The drywall ceiling is bowed downward in the area of the ceiling ventilation fan. This condition may have been caused by the rusty ventilation fan.

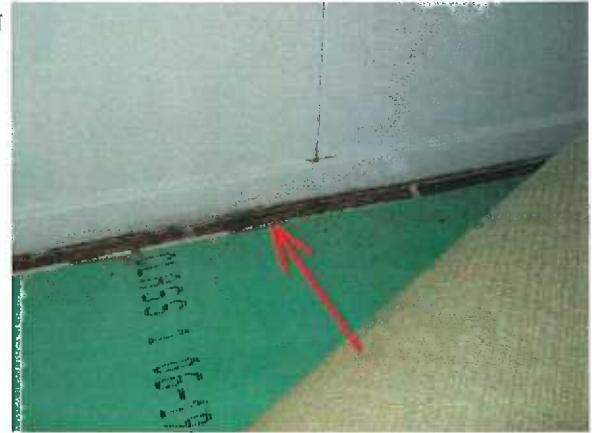
1. ☐ ☐ ☐ ☒ ☐ Closet: Single The closet door needs to be adjusted to fit into the opening properly.
2. ☒ ☐ ☐ ☐ ☐ Ceiling: Drywall
3. ☒ ☐ ☐ ☐ ☐ Walls: Drywall
4. ☐ ☐ ☐ ☒ ☐ Floor: Carpet The carpet tack strip along the unit party wall, the strip is stained and the tacks are rusty.

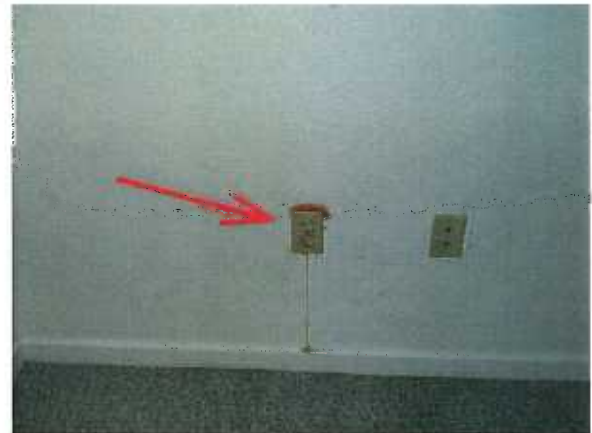
5. ☒ ☐ ☐ ☐ ☐ Doors: Painted, Flush Solid Core
6. ☒ ☐ ☐ ☐ ☐ Windows: Andersen, Double Hung, Tilt and Wash
7. ☐ ☐ ☐ ☐ ☒ Electrical: Fan, Light & Receptacles The electrical outlet is rusty. This was caused by moisture in the party wall.

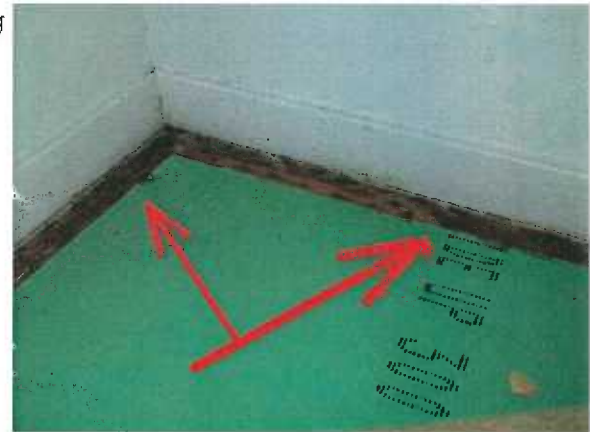
7. ☒ ☐ ☐ ☐ ☐ Closet: Single
 8. ☒ ☐ ☐ ☐ ☐ Ceiling: Drywall
 9. ☒ ☐ ☐ ☐ ☐ Walls: Drywall
 10. ☐ ☐ ☐ ☐ ☒ Floor: Carpet The carpet tack strip along the unit party wall, the strip is stained and the tacks are rusty.

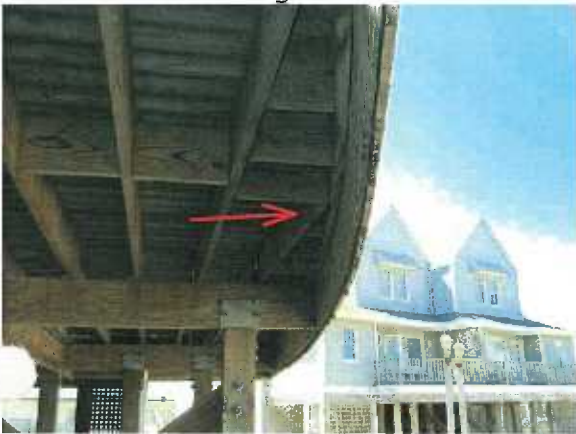
1. **Deck: Front, Pressure Treated Wood** The front deck handrails and wood pickets are deteriorated and should be replaced. One of the deck floor joist is not properly installed with a ledger or metal joist hanger. From under the deck, the floor joist below the party wall above, the floor joist are stained. This indicates that moisture is migrating from the roof through the party wall and exiting under the house in the carport.

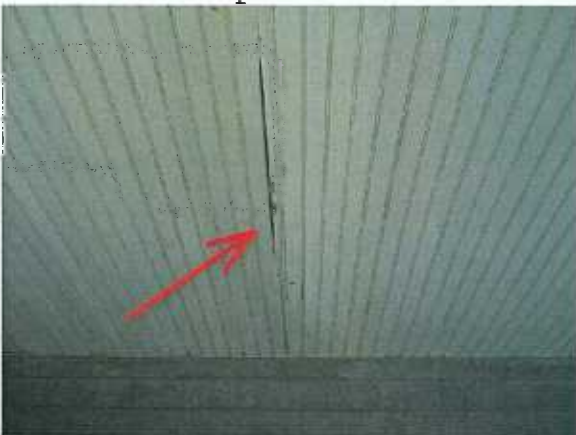
2. **Porch: Rear Porch, Pressure Treated Wood** Screen panels for the porch are missing or damaged. The porch screen door is damaged. There is one place where the ceiling soffit panels are bulging down ward.

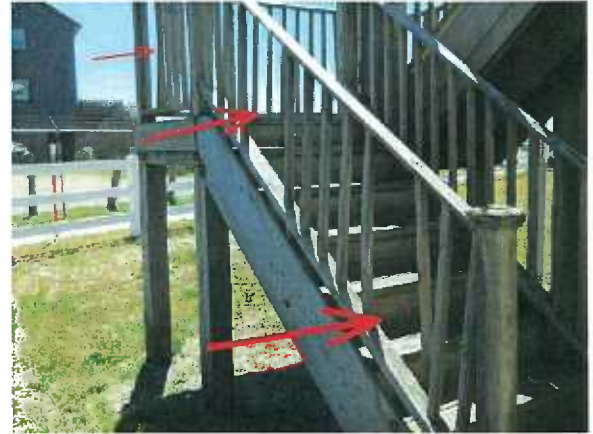
3. **Stairs/Landings:** Rear Stairs & Landing, Pressure Treated Wood The 2X2 wood pickets are loose and missing. The nails holding the pickets in place have rusted away.

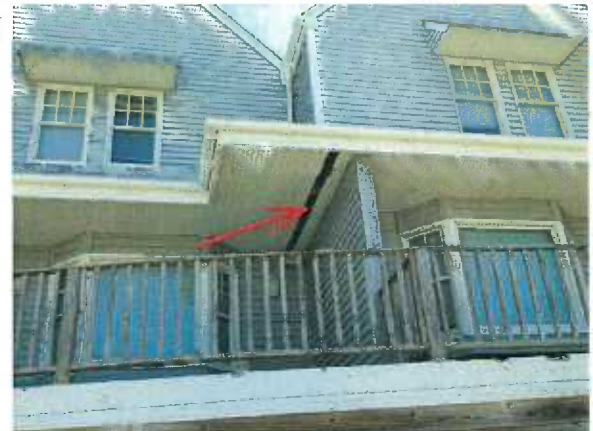
4. **Soffits:** Vinyl panels There is one soffit panel missing from the soffit at the front of the house.

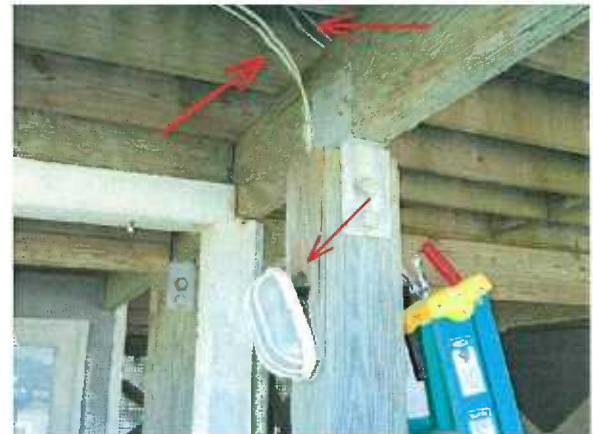
5. **Exterior Lighting:** Exterior, Surface Mount There is one light fixture at the front of the house that is not properly mounted to its intended surface. There is a exterior light under the front deck that was wired with interior romex wiring that should have been installed in electrical conduit. There is a light installed for the rear stairs. The interior romex wiring for this light should have been installed in electrical conduit.

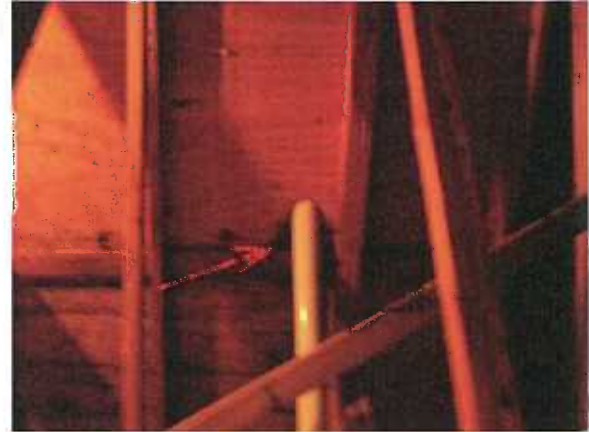
7. Plumbing Vents: PVC The 3 inch plumbing vent, there are moisture stains around this pipe in the attic that indicate the plumbing vent has failed.

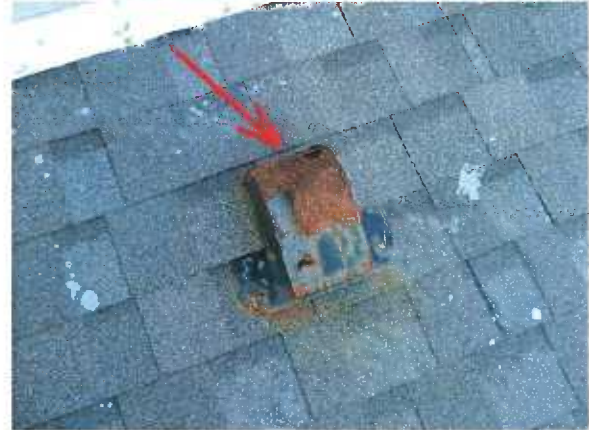
8. Ventilation Vent: Metal One of the metal ventilation vents is deteriorated to the point it is allowing moisture to enter the interior of the house.

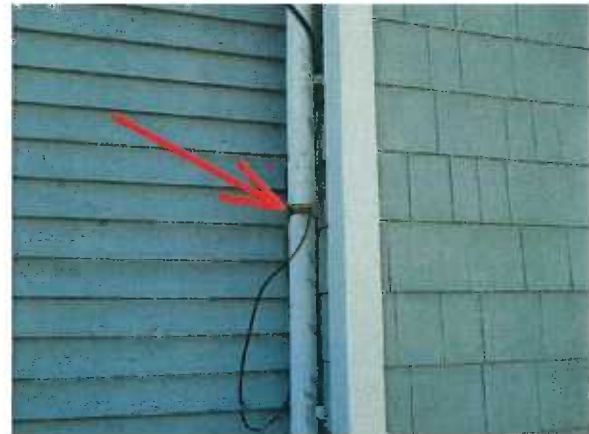
9. Gutters: Plastic Pieces of the gutter are missing, other parts are not properly connected together.
10. Downspouts: Plastic The gutter down spout has become disconnected.

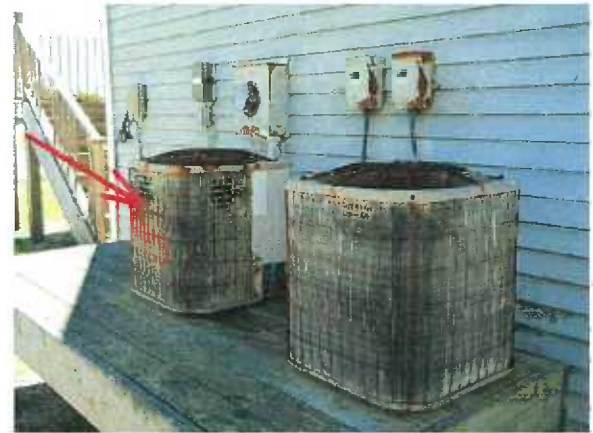
14. **North Side AC System A/C System Operation:** Inoperative
15. **North Side AC System Visible Coil:** Copper core with aluminum fins The aluminum fins surrounding the copper coil are becoming deteriorated and falling away from the copper coil. The aluminum fins are present to dissipate the heat from the copper coil and when the fins are no longer present the coil will over heat and the condenser will cease to function.

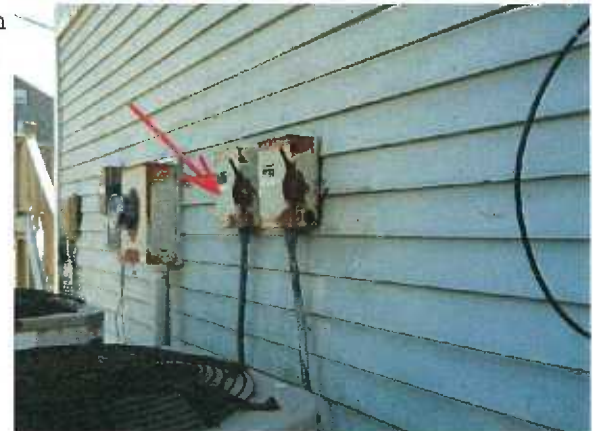
16. **North Side AC System Refrigerant Lines:** Rubbertex Insulation The black rubbertex insulation on the copper tubing is deteriorated and should be replaced.

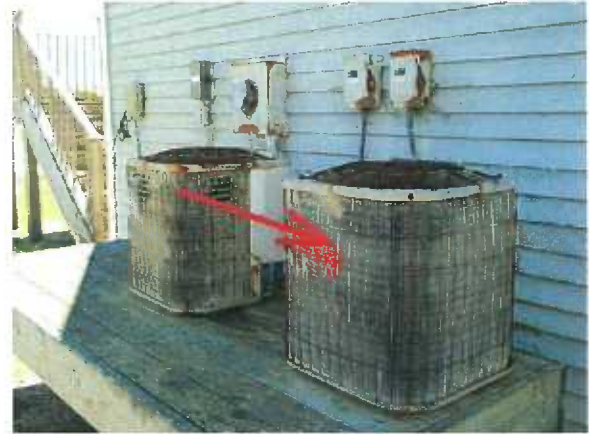
18. North Side AC System Visible Coil: Copper core with aluminum fins The aluminum fins surrounding the copper coil are becoming deteriorated and falling away from the copper coil. The aluminum fins are present to dissipate the heat from the copper coil and when the fins are no longer present the coil will over heat and the condenser will cease to function.

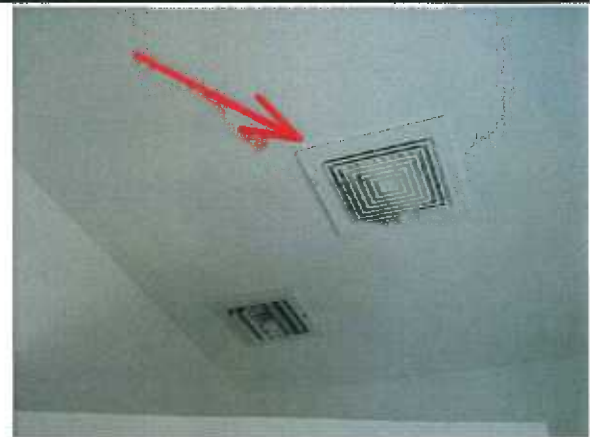
21. Main Level Powder Room Bathroom Ceiling: Drywall The drywall ceiling is bowed downward in the area of the ceiling ventilation fan. This condition may have been caused by the rusty ventilation fan.

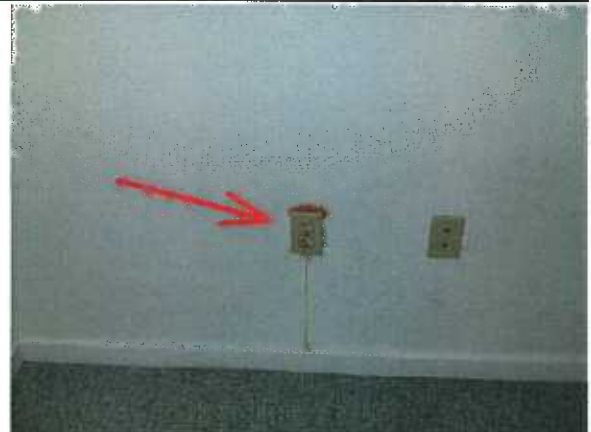
24. Rear Right Bedroom Electrical: Fan, Light & Receptacles The electrical outlet is rusty. This was caused by moisture in the party wall.

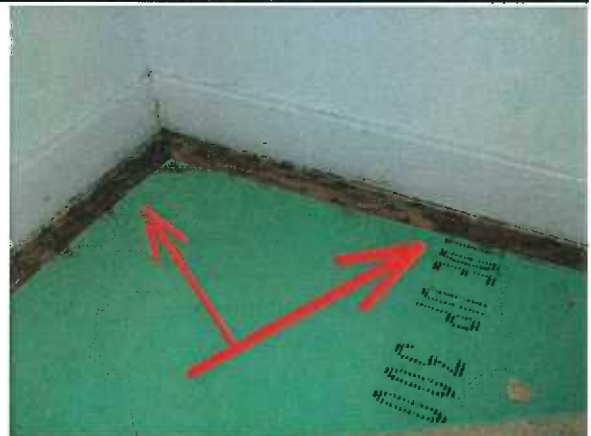
25. Main Level Living Area Living Space Floor: Carpet The carpet tack strip along the unit party wall, the strip is stained and the tacks are rusty.

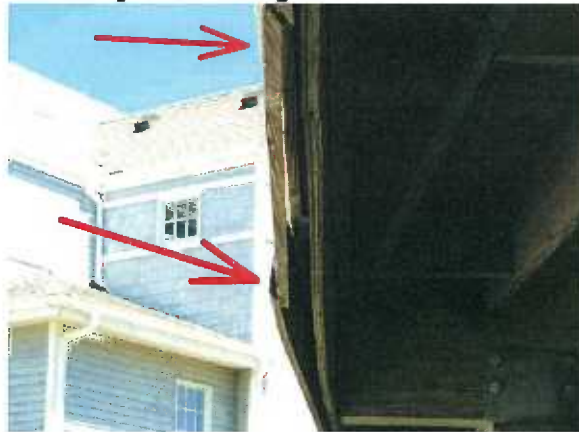
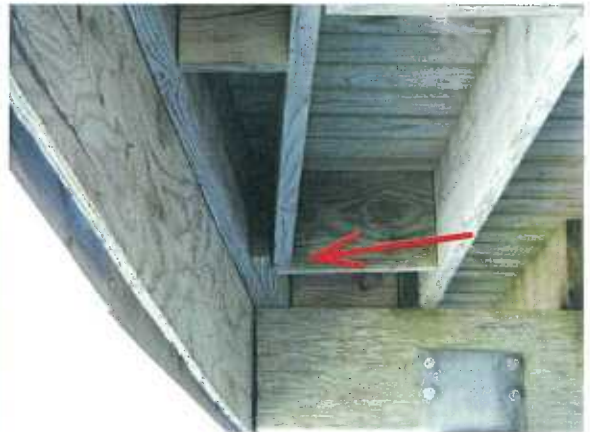
Deck: Front, Pressure Treated Wood The front lower trim boards are loose and need to be re nailed.

One of the deck floor joist is not properly supported with a ledger or metal joist hanger.

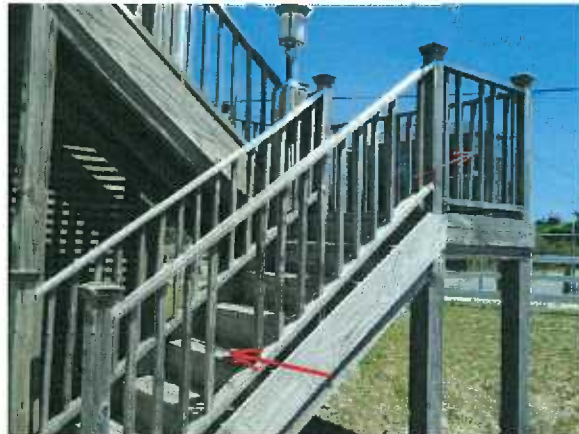
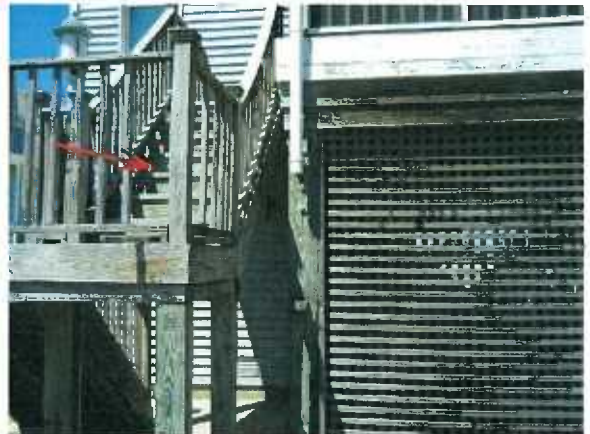
6. ☐ ☐ ☐ ☐ ☒ Stairs/Landing: Rear Stairs & Landing, Pressure Treated Wood The wood pickets are loose or out of place. The nails used to secure the pickets are rusty/deteriorated.

The wood trim skit boards are loose and need to be re nailed.

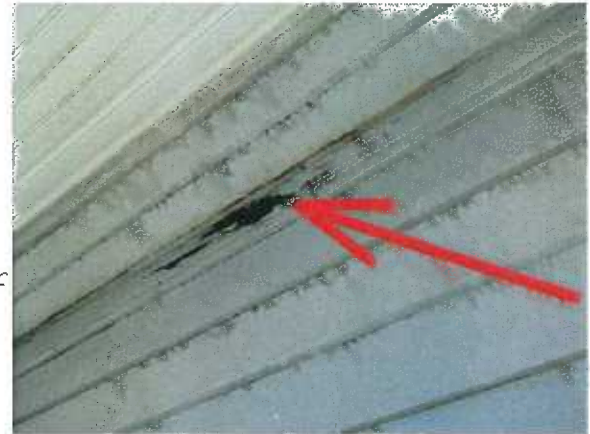
7. ☐ ☐ ☐ ☐ ☒ Type: Horizontal Wood Ship Lap Siding
The party wall at the rear screen porch. The siding is visibly deteriorated. An invasive inspection is needed to determine the extent of damage.
All exterior wall surfaces should be examined and re nailed in the areas where is has become loose. The exterior of the house should be pressure washed and repainted.

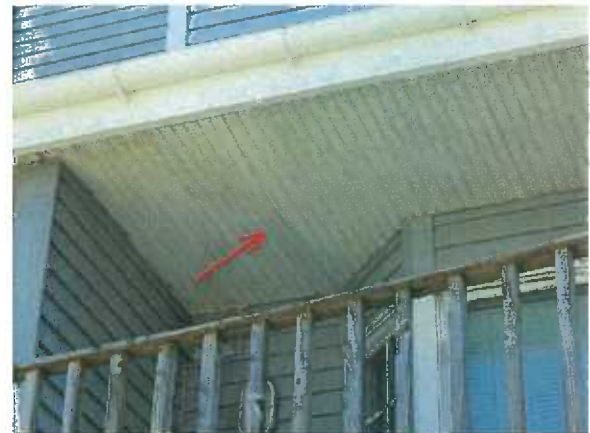
8. ☐ ☐ ☐ ☒ ☐ Type: Plywood Panels with machine shake appearance. The machine shake look plywood panels, the nails are loose in several places. The exterior walls should be examined and the loose siding re nailed. The exterior of the house should be pressure washed and repainted.
9. ☒ ☐ ☐ ☐ ☐ Trim: Wood, Aluminum Covered
10. ☒ ☐ ☐ ☐ ☐ Fascia: Wood, wrapped with Aluminum Coil Stock
11. ☐ ☐ ☐ ☐ ☒ Soffits: Vinyl panels The soffit panels above the front deck are bulging down.

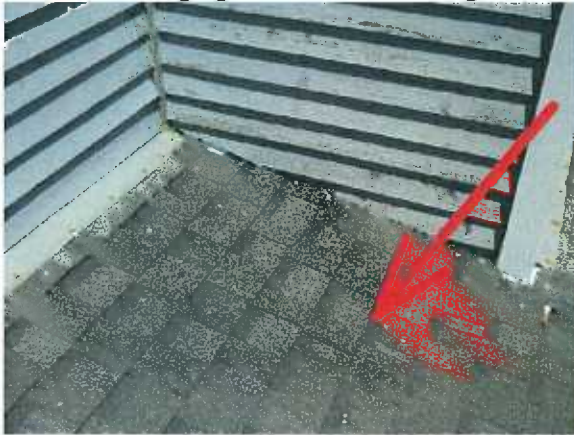
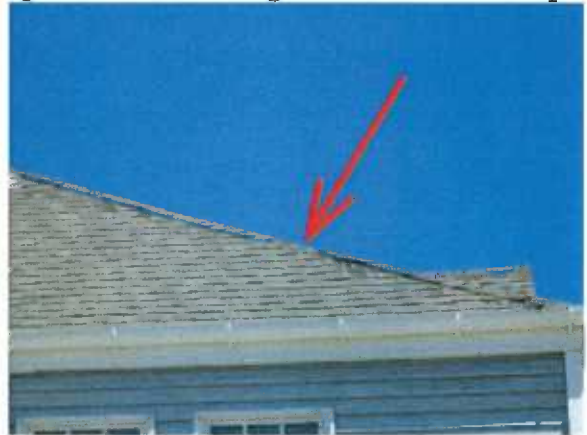
1. Method of Inspection: On roof
2. ☐ ☐ ☐ ☐ ☒ Material: Asphalt shingle There are ridge cap shingles missing from this roof.
At the intersection the rear units walls, there is an area about 6'X6' where the plywood sheathing is very soft and dangerous to walk upon.

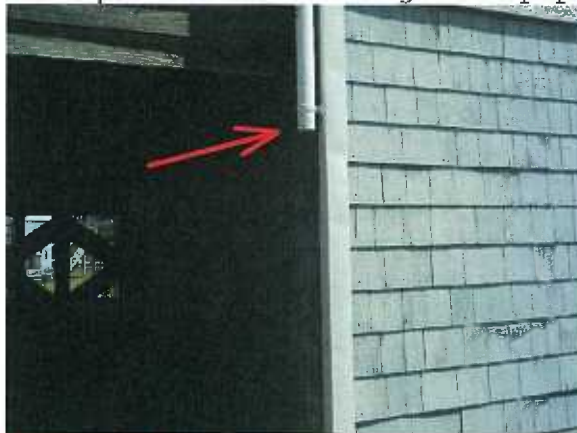
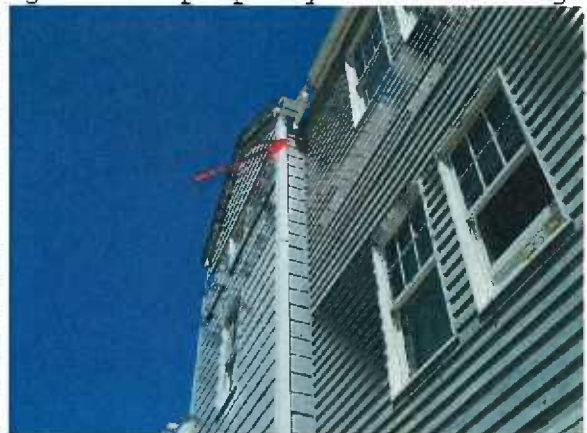
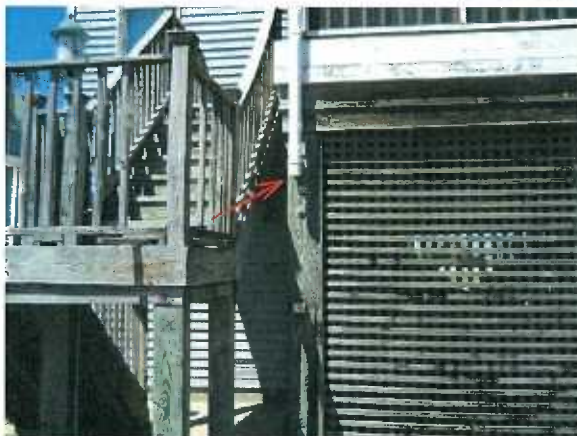
9. ☐ ☐ ☐ ☒ ☐ Gutters: Plastic Pieces of the gutter are missing, other parts are not properly connected together.
10. ☐ ☐ ☐ ☐ ☒ Downspouts: Plastic The gutter piping is not properly connected together.

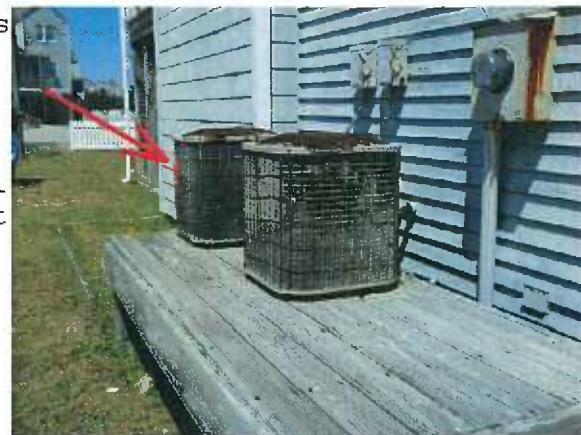
1. ☐ ☐ ☐ ☐ ☒ A/C System Operation: Inoperative The unit is nearing the end of the manufactures stated design life
2. ☒ ☐ ☐ ☐ ☐ Condensate Removal: Plastic tubing
3. ☒ ☐ ☐ ☐ ☐ Exterior Unit: Mounted on wooden platform
4. Manufacturer: Goodman
5. Area Served: Ground & Mid Levels Approximate Age: 12 to 14 years
6. Fuel Type: Electric Temperature Differential: x
7. Type: Heat pump Capacity: 2 ton
8. ☐ ☐ ☐ ☐ ☒ Visible Coil: Copper core with aluminum fins
The aluminum fins surrounding the copper coil are becoming deteriorated and falling away from the copper coil. The aluminum fins are present to dissipate the heat from the copper coil and when the fins are no longer present the coil will over heat and the condenser will cease to function.

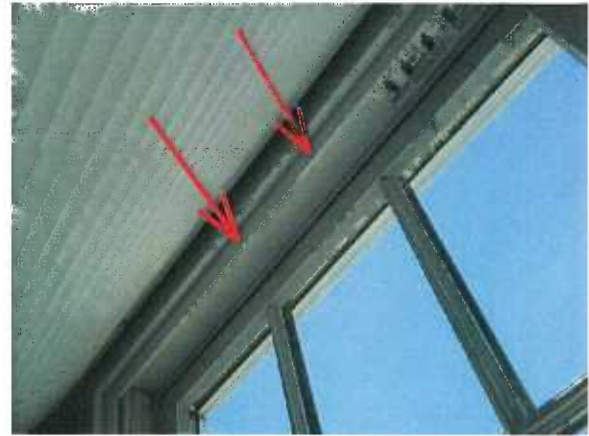
13. Stair Well Living Space Windows: Andersen, Double Hung, Tilt and Wash There are drip stains on the vinyl header piece of the window on the outer wall.

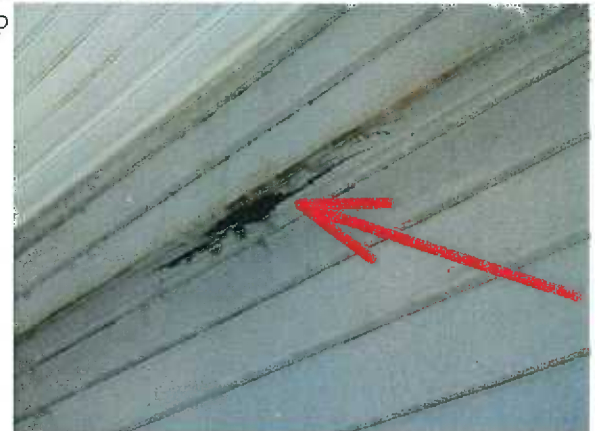
3. **Exterior Walls** Exterior Surface Type: Horizontal Wood Ship Lap Siding The party wall at the rear screen porch. The siding is visibly deteriorated. An invasive inspection is needed to determine the extent of damage.
All exterior wall surfaces should be examined and re nailed in the areas where is has become loose. The exterior of the house should be pressure washed and repainted.

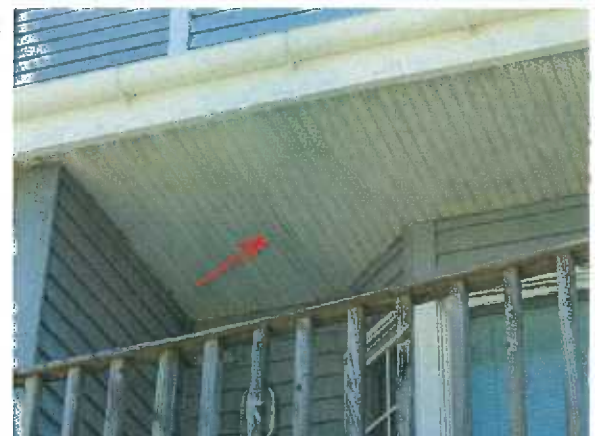
4. **Soffits:** Vinyl panels The soffit panels above the front deck are bulging down.
